THE BRAKING PERFORMANCE OF AN AIRCRAFT TIRE ON GROOVED PORTLAND CEMENT CONCRETE SURFACES

Satish K. Agrawal
Hector Daiutolo

FEDERAL AVIATION ADMINISTRATION TECHNICAL CENTER
Atlantic City Airport, N.J. 08405

INTERIM REPORT

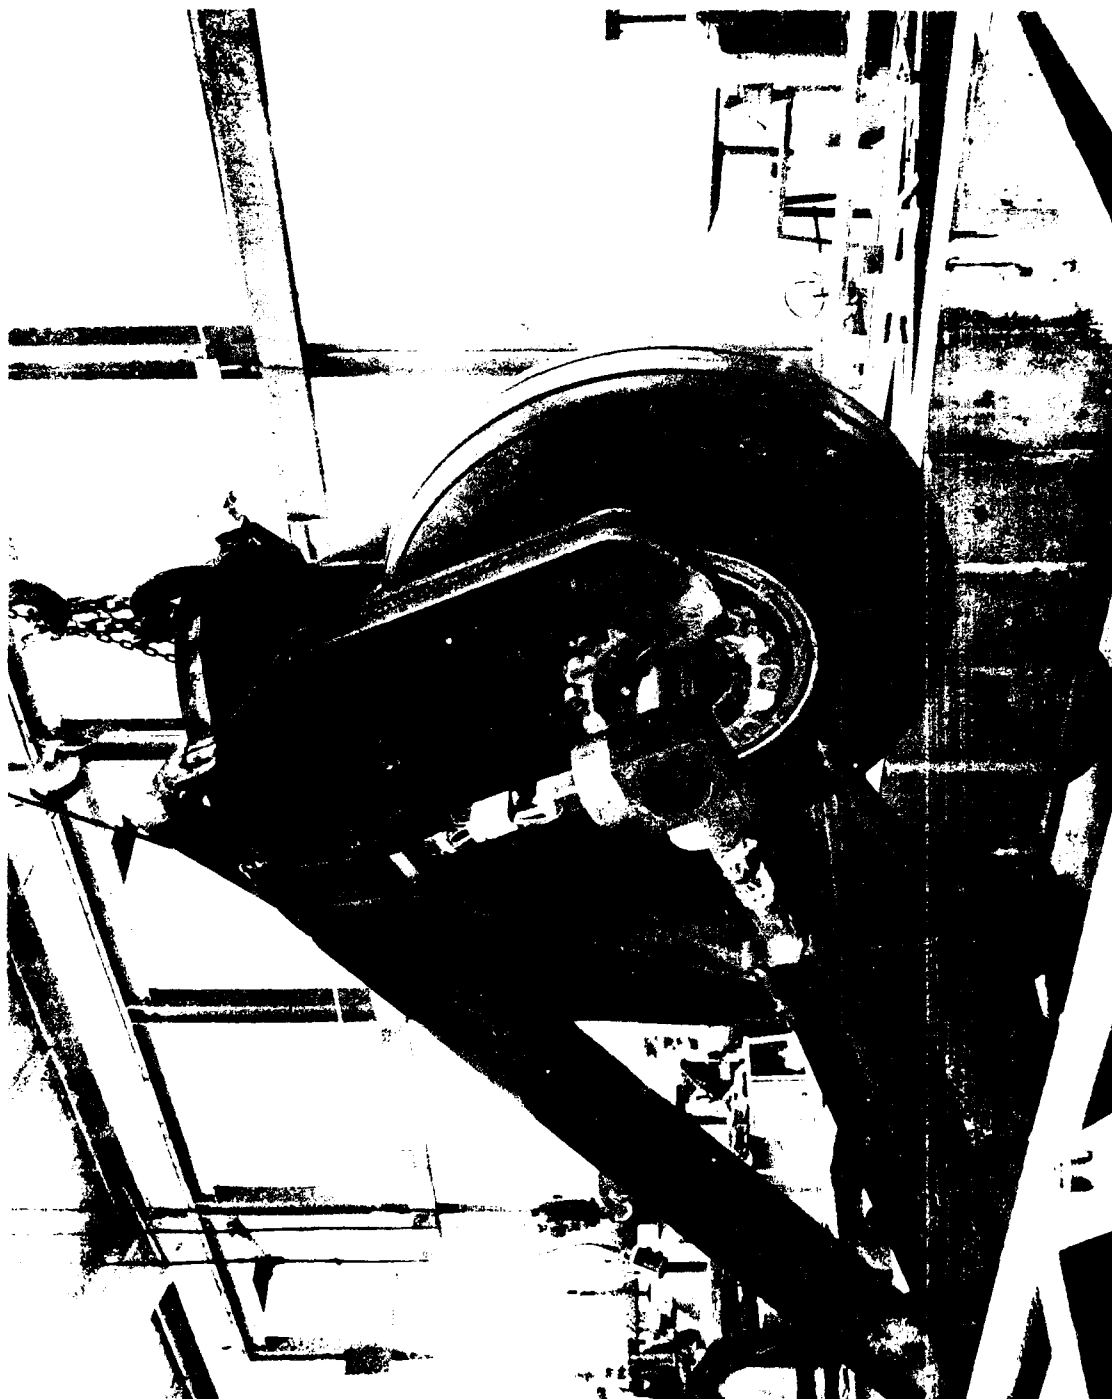
FIGURE 5. DYNAMOMETER AND WHEEL ASSEMBLY SHOWING VERTICAL AND HORIZONTAL LOAD LINKS
